State of Oregon
Department of Environmental Quality

Memorandum

Date: July 19, 2007

Subject: Recommendation for No Further Action,
Paco Pumps ECSI # 146

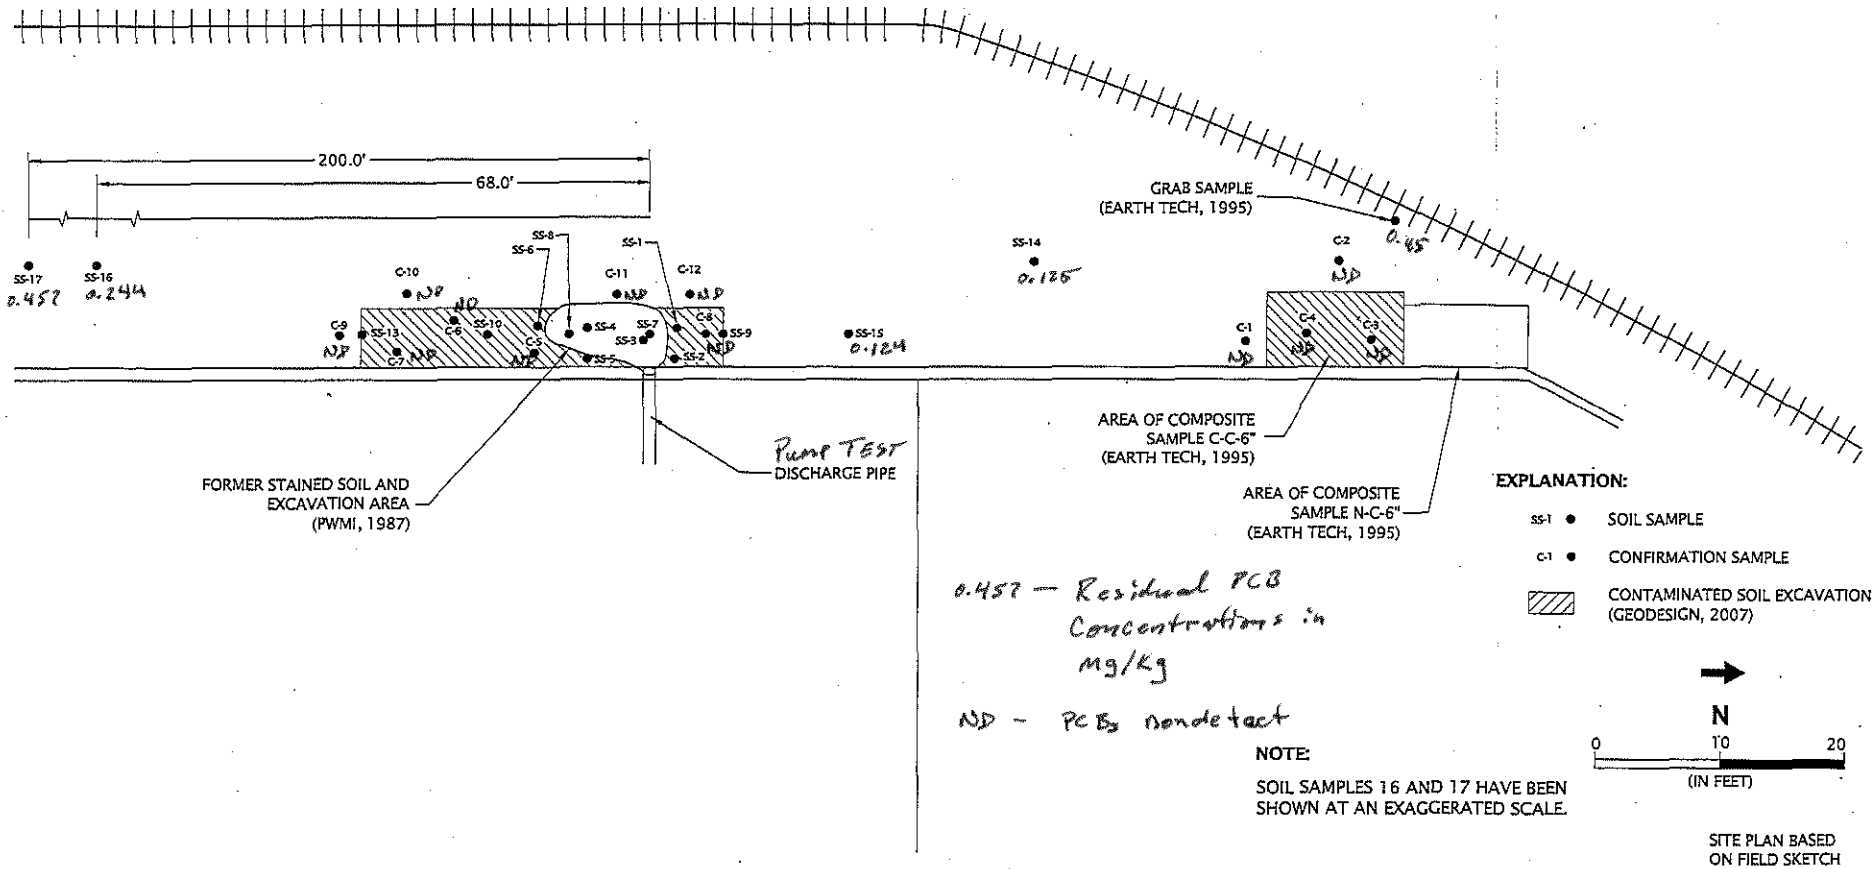
DWG Name: SulzerPump-3-01-1359.dwg | Layout: fig 3 | Updated by: aday | Date: 4/3/2007 9:40:11 AM

- In 2006, GeoDesign used the results of a geophysical survey to locate a heating oil underground storage tank (UST) east of the building office (as shown on Figure 3). The UST had been previously decommissioned in place by filling with concrete slurry in 1993. GeoDesign completed two soil borings at either end of the UST. No field indications of contamination were observed on soil in the two borings. Testing included sheen testing, headspace vapor readings, and visual and olfactory evaluations to a depth of 15 feet in the borings. Two soil samples from 9 to 10 feet depth were analyzed for total petroleum hydrocarbons with nondetectable results.

In January 2007, GeoDesign removed an additional 17.97 tons of soil from the contaminated area. GeoDesign estimated that the depth of PCB impacts were limited to approximately 1 foot, but excavated to 1.5 feet below ground surface as a conservative measure. PCBs were not detected in any of the post-removal soil confirmation samples collected at depths of 0.5 to 1.0 feet and 1.5 to 2.0 feet. Detection limits ranged from 0.0796 mg/kg to 0.0847 mg/kg. The PCB soil concentrations outside of the removal area ranged from nondetect to 0.457 mg/kg. Only PCB Aroclors 1254 and 1260 were detected (attached Figure 3).
